MITSUBISHI MOTOR SALES OF AMERICA, Inc.

TECHNICAL SERVICE BULLETIN

1988 TRUCK SIDE WINDOW SPACER

NO.	TSB-88-23-010
DATE	August, 1988
MODEL	1989 Truck

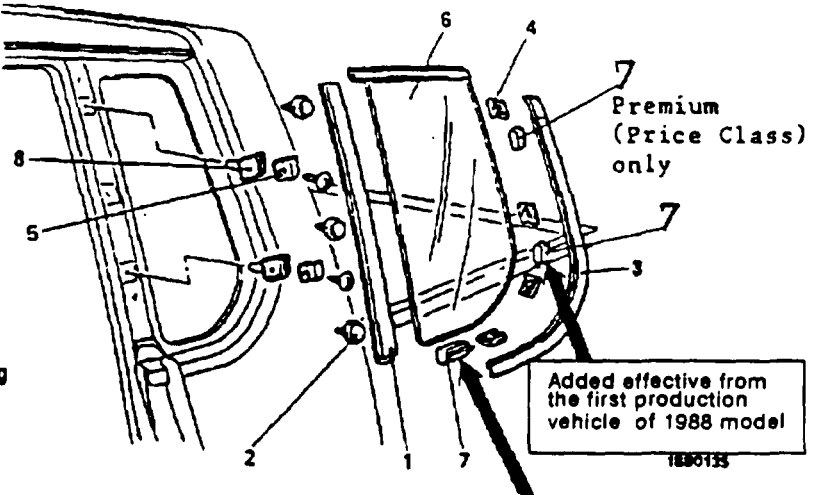
BODY – Side Window Glass 23-27

Page 23-27: The lower window spacer is not used, and a center spacer is added as shown in the illustration below.

- ◆◆ 1. Center pillar garnish
- 2. Trim clip
- ◆◆ 3. Side window lower molding
- 4. Window molding clip
- 5. Glass holder
- ◆◆6. Side window glass
- ◆◆7. Window spacer
- 8. Side window spacer

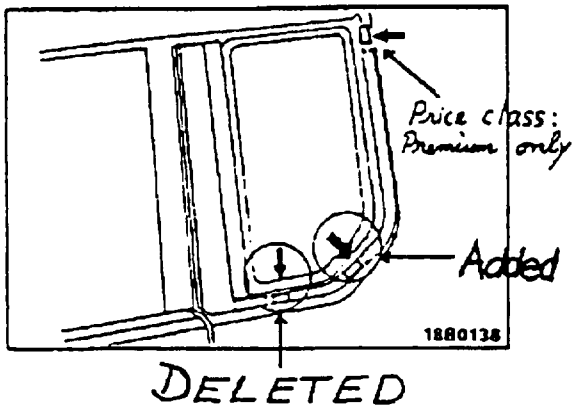
Page 23-28: Revise the illustration on this page as shown.

7. INSTALLATION OF WINDOW SPACER

Align the window spacer with the edge of the windc
ing clip and install in the position shown in the diagr
